Affidavit – James Barton 2 (May 15, 2008)

James Barton
Affidavit
RANGE VISIT TRACER TEST

After inspecting the FBI range facility on Monday, April 28
I made the following report:

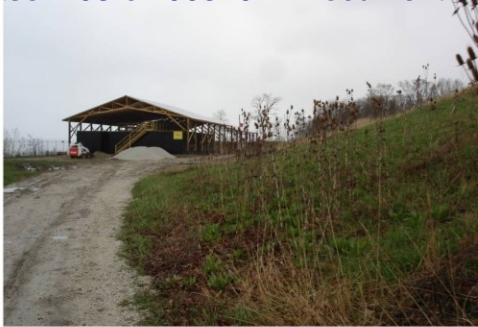
Shoot house

Bullets are leaving the shoot house on the edge of the bluff and may present an endangerment to adjacent properties.

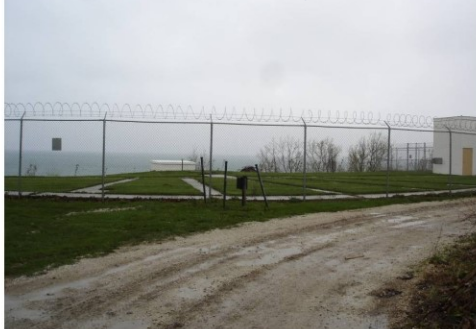
Looking at shotgun range with lake in background

3. Bullets discharged from this facility into Lake Michigan occurs directly over two potable water intake cribs that supply drinking water to the City of North Chicago.
